A Increasing Vertical Dimension: Considerations and Steps in Reconstruction of the Severely Worn Dentition

Steven T. Cutbirth, DDS*

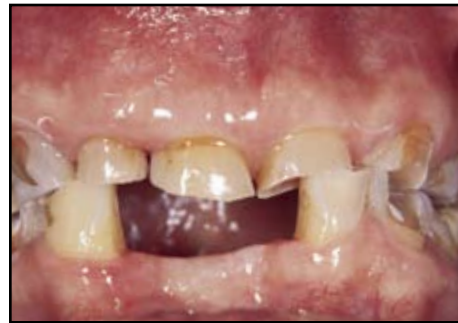
Figure A. Clinical example of severely worn dentition that results in a loss of vertical dimension of occlusion (VDO).

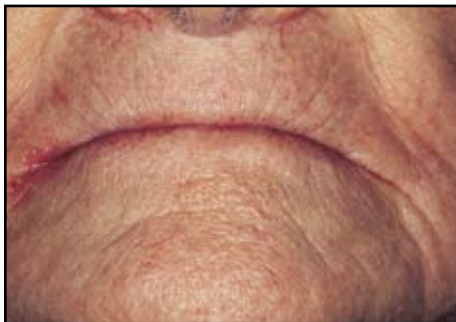
Figure B. Clinical view of patient who demonstrates signs of lost VDO. Note the down-turned lips when the patient is in closure.

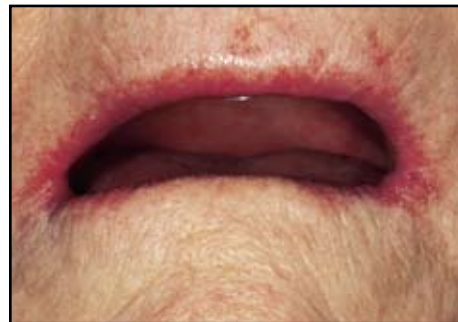
Figure C. Clinical appearance of angular cheilitis at the corner's of the patient's mouth, a sign of lost vertical dimension.

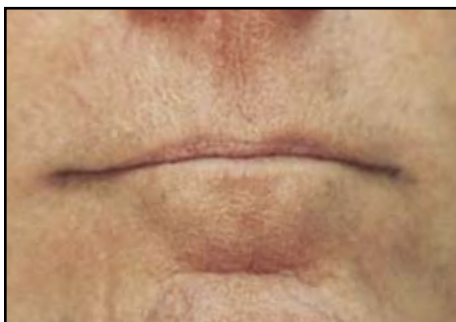
Figure D. Preoperative view of the patient demonstrates his vertically compressed appearance with his teeth closed.

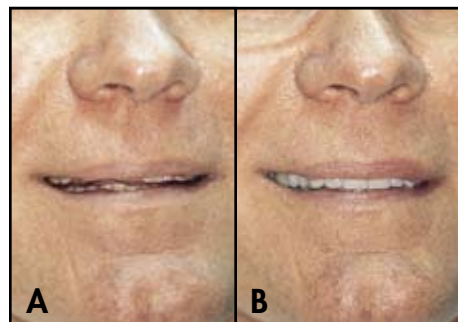
Figure E. Preoperative and post-operative view of the improved aesthetics and increased VDO achieved through the predictable restorative process.
